INVENTORY FORM FOR STATE HISTORIC SITES SURVEY

STREET & NUMBER 18 Willow Avenue

BA-2163

PHOTOGRAPHS: 18 Willow Avenue

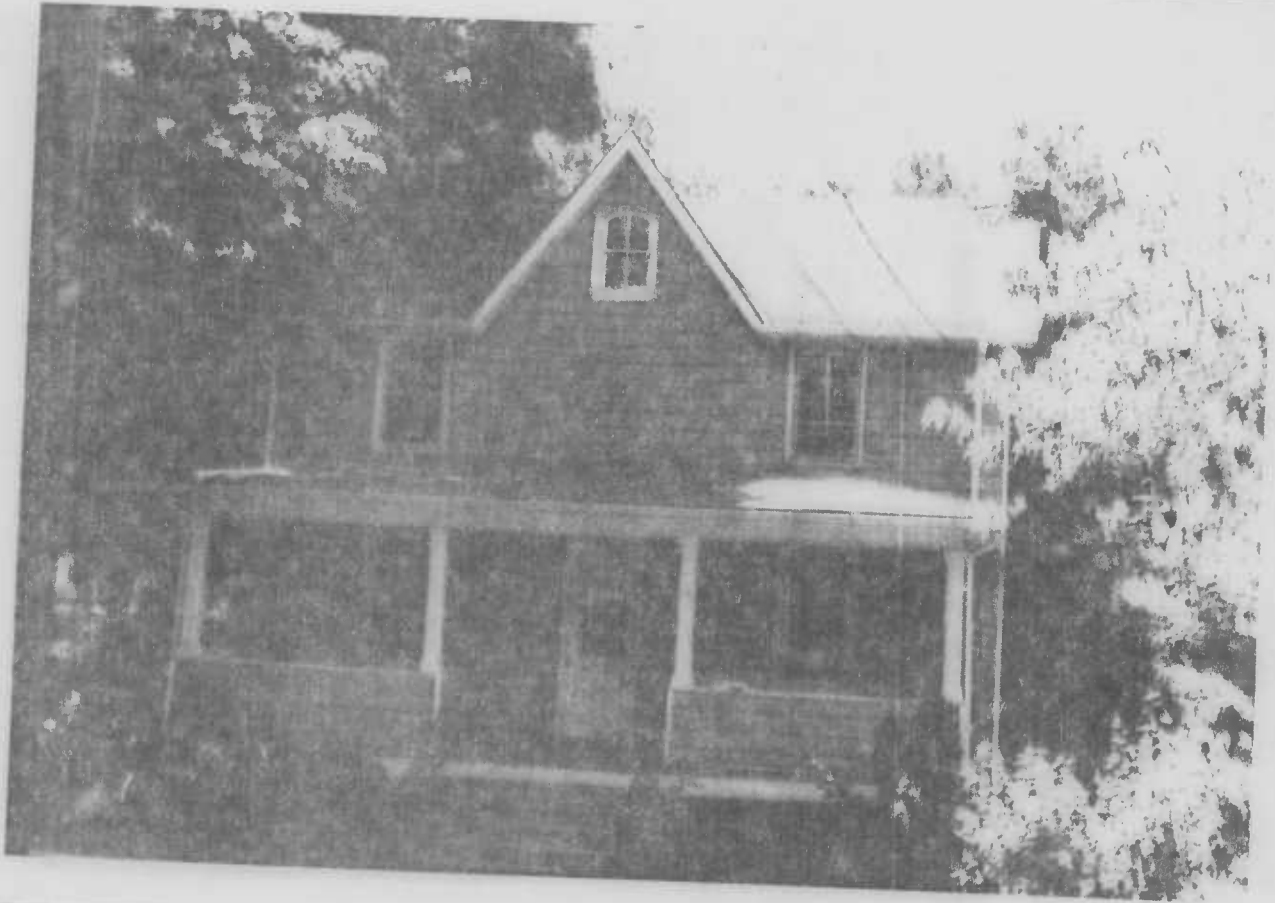
BELOW: North-west Corner

The house faces north on Willow Avenue. Essentially, the structure follows a two room wide central hall plan with additions made to the rear. Six concrete steps lead to the front porch which spans the entire north facade and is floored with tongue and groove ceiling underneath.

The entrance is centrally located at the top of the porch steps. It consists of a wood door with a square inset wood panel in the upper half and two rectangular inset panels on the lower half. A closed-in transom rests above the door. On each side of the door is a 2/2 sash window encased in plain white trim. Fenestration on the second floor consists of two 2/2 sash windows with plain white trim. The attic contains one arched 2/2 sash window.

The view of the west facade is obstructed by poison ivy, weeds, and overgrown bushes. One does see the chimney flue, covered with formstone. To the left of the flue is a 2/2 sash window on the first floor and a 2/2 sash window on the second floor. To the right of the flue is a 1/1 sash window on the first floor and one on the second floor. Fenestration on the addition is obstructed.
